SPECTRA ENGINEERING PTY LTD

MX800 Important Firmware Update

MOTHERBOARD BUILD VERSION C OR LESS WITH NEW RELEASE FIRMWARE

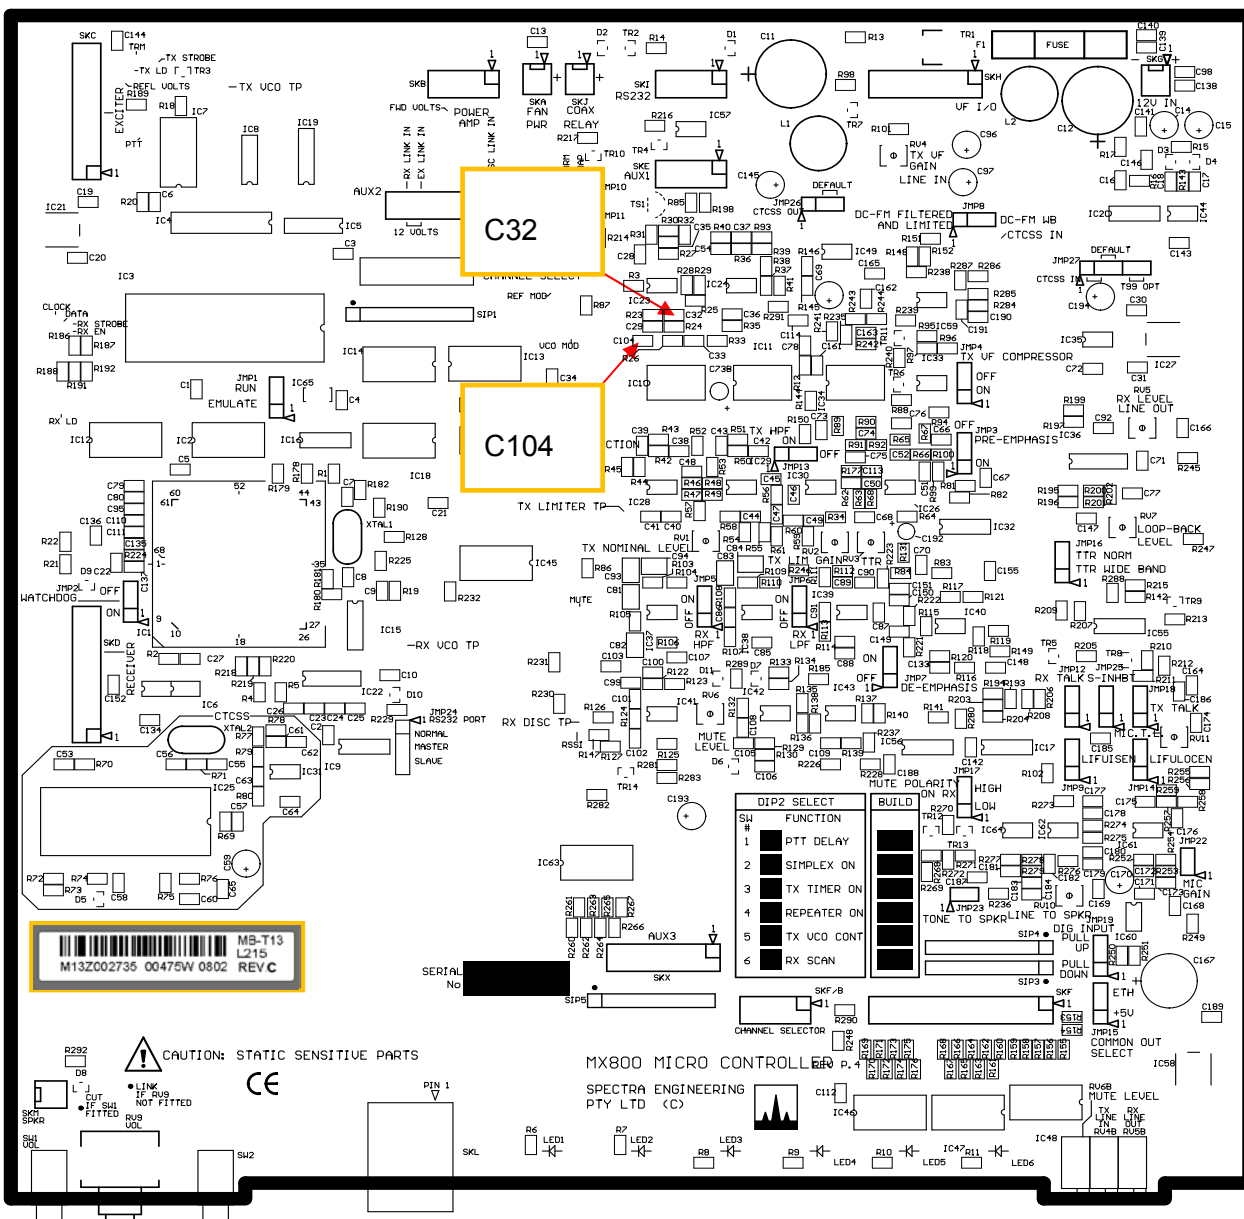
It is not recommended to upgrade the firmware without the hardware change as it has been designed to work together. Failure to do so may result in degradation of the transient performance resulting in some adjacent channel splatter.

MX800 mother boards with a build revision equal to and less than 'C' would be affected by this upgrade if installed latest firmware versions are $\geq 3.5.14$.

The only way to correct the identified issues is to swap mother board PCB components C32 & C104 over when upgrading firmware.

REMOVE	C32	1nF 0805 X7R
FIT	C32	10nF 0805
REMOVE	C104	10nF 0805
FIT	C104	1nF 0805 X7R
